AGENDA SPECIAL COUNCIL MEETING

Monday 31 July 2023

Barkly Regional Civic Centre Inspection Report

18-Jul-2023
Barkly Regional Council Civic Centre Audit
Commercial-in-Confidence

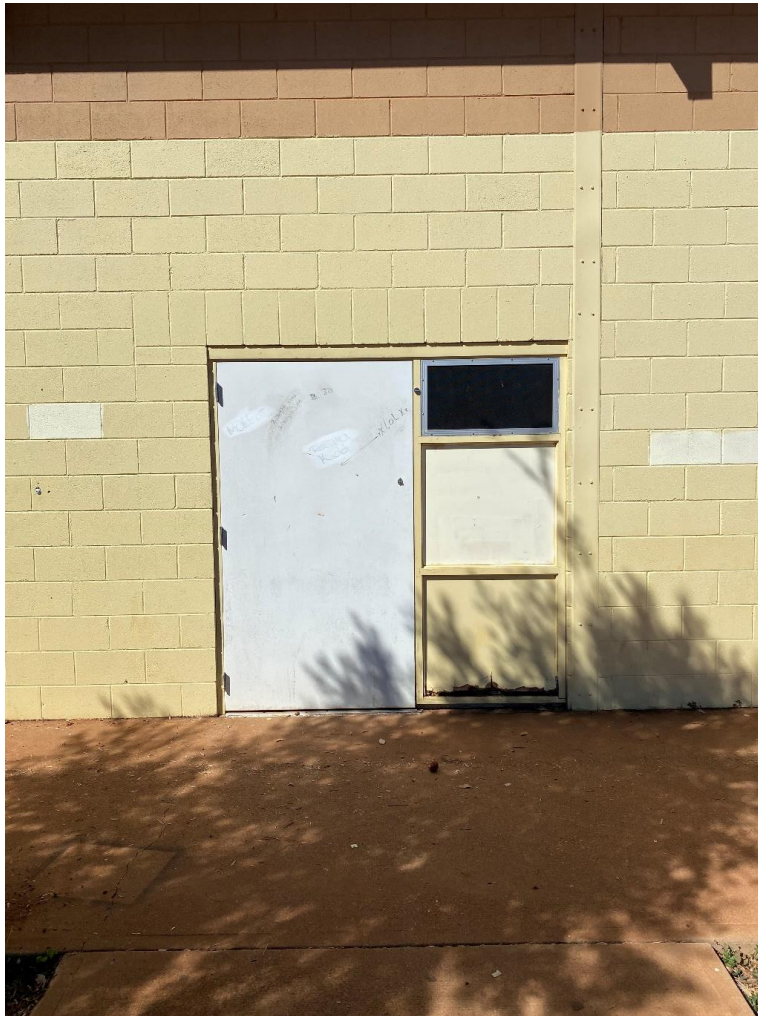
The building is constructed with a structural steel portal frame and blockwork throughout with metal roof sheeting. The roof structure and condition were not accessed or assessed. The roof sheeting was in good condition. There is no guttering or downpipes with any rainwater dropping directly onto the ground which was generally concrete around the building. No drainage or stormwater management was observed on site. All external windows are provided with metal security screens. The external doors and side leaf panels are in average condition with water damage to the external fabric to the side panels as shown in Figure 3 below. It is recommended that the doors and side panels be replaced with double door arrangement complete with push bar for emergency egress with vertical slide bolts for security.

Figure 3 - Door Side Panel Showing Water Damage

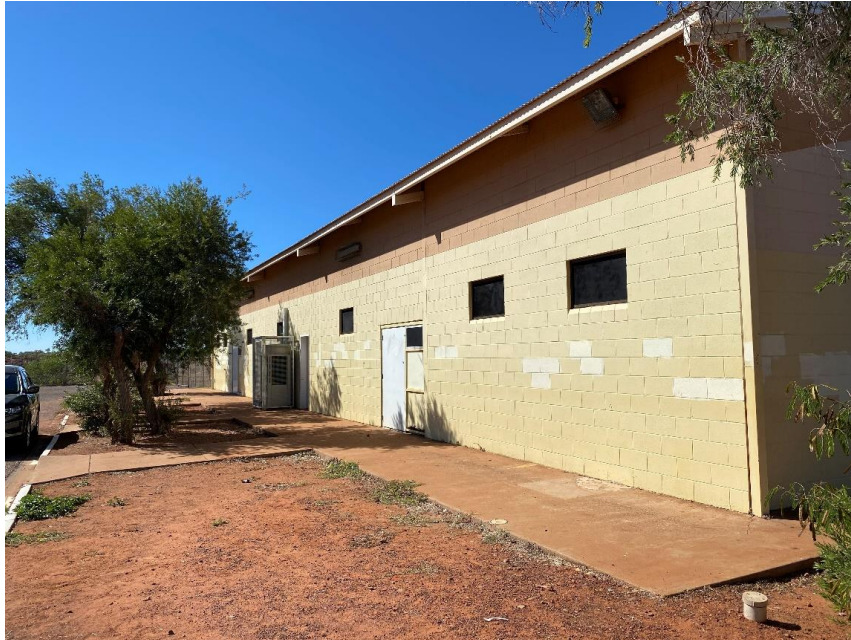
The building external fabric, painted finish blockwork, is in fair condition with no visible sign of damage and/or major cracking to the blockwork. There are some minor areas of movement evident from the mortar joints in the blockwork. The paint finish appears dated with patches of repainting to cover most likely vandalism.

Figure 4 - External Paint Finish Showing Patch Work Repaint

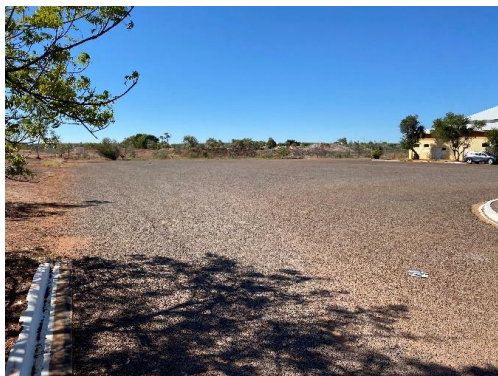
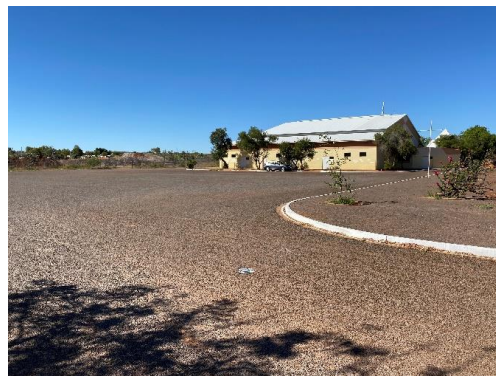
The external car parking area is spray sealed only with loose screenings on the surface. There does not appear to be any issues with the levels of the car park and no visible signs to indicate ponding during rain events. It would appear that the carpark falls away from the building towards the adjoining culvert running along the western side boundary of the car park. There does not appear to be any major cracking or surface deformations. It was noted from a previous visit to the site that the car park could hold 100+ vehicles and this could be extended further by providing line marking rather than relying on individuals to assume where parking begins and ends. In addition, it is recommended that the car park be correctly sealed in asphalt and then line marked.

Figure 5 - Car Park

Figure 6 - Car Park

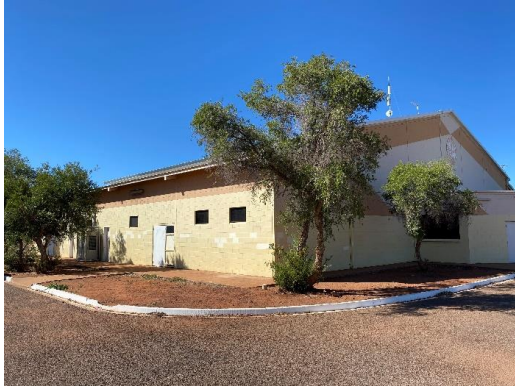
A concrete kerb is provided to the frontage of the car park facing Peko Road and the loop to the building entrance and along the eastern side of the car park. The concrete kerb is in fair condition with some damaged areas where concrete has broken or been chipped away. The kerb paint work is fading in some parts with tyre marks through various sections however generally in fair to good condition. With the

Figure 7 - Condition of Kerb

recommended works to reseal the car park the sections of damaged kerb will need to be repaired and the kerb repainted.

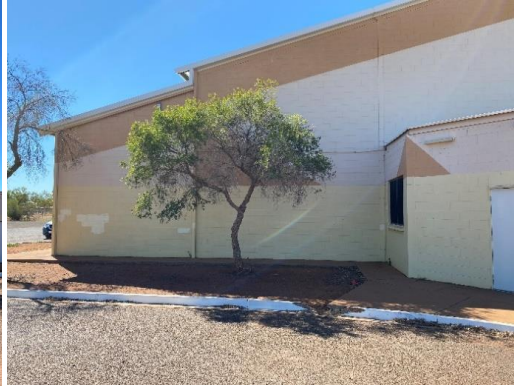
Figure 8 - Condition of Kerb - Damage Evident

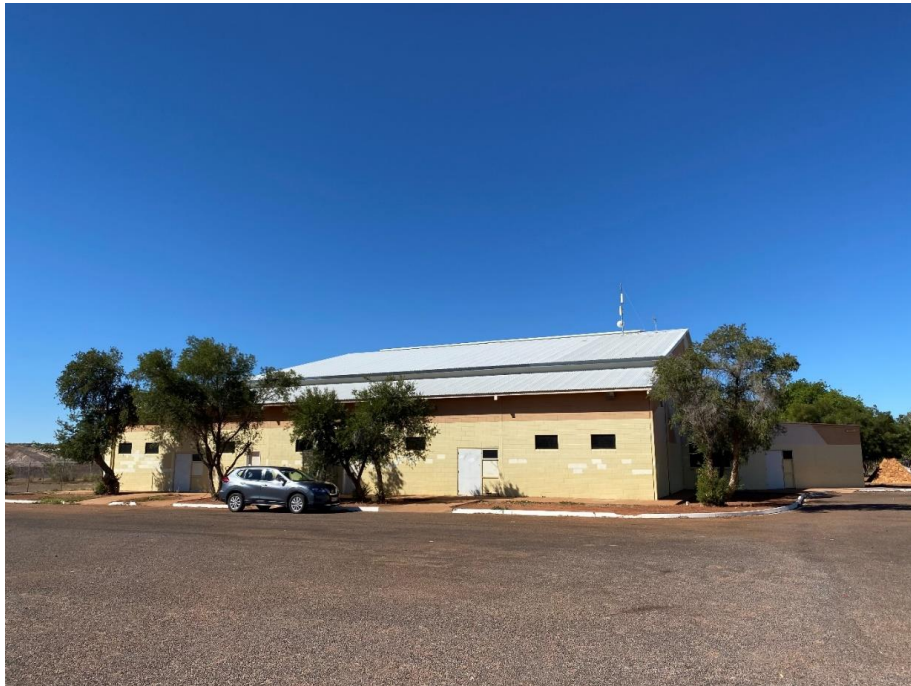
The roof sheeting is in very good condition with no signs of staining or general wear and tear. There are no gutters or downpipes provided to the centre with rainwater falling directly onto the surrounding surfaces at ground level. There is a concrete path around the entire building which is generally in good condition with no major cracks or movement evident.

Figure 9 - Roof

The existing roof would be suitable for a solar system. It is recommended that the solar system be based on the maximum daily use rather than oversized given that current PWC requirements prevent export to the network. The solar system recommended would be approximately 45kW system which would require approximately 180 x 250W panels requiring approximately 480sq meters of roof space.

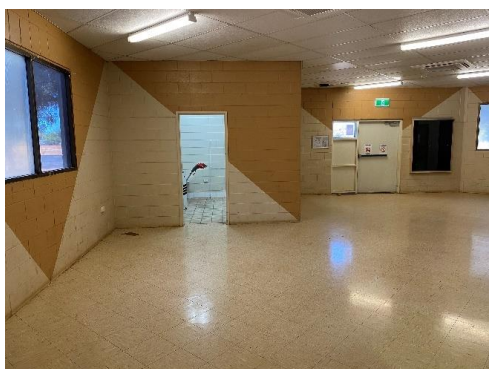
The concrete slab is covered with direct stick vinyl flooring throughout the main public areas. The bar, kitchen, stage change rooms and toilets are all floor tiles which again are in fair condition however showing their age.

Figure 10 - Entrance Lobby Vinyl Flooring

The entrance lobby vinyl floor is dated however a high traffic finish, such as tiling or a fake timber floor panel, is recommended. The final colour should take into consideration the red dirt typically evident throughout the Northern Territory, so therefore white floor tiles are not a good option.

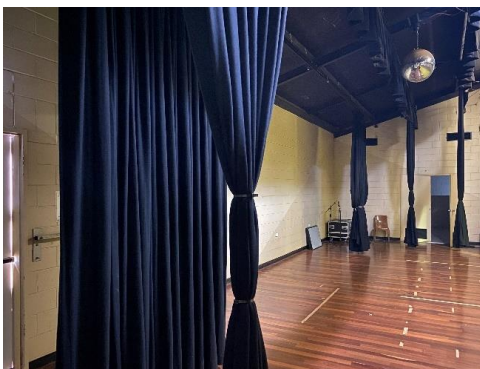
Figure 13 - Stage Timber Floor

The stage timber floor is in very good condition. To maintain its condition, it is recommended that the timber surface is polished yearly with any rough surfaces sanded and treated at the time. It would also be recommended that the timber floor be lightly sanded and revarnished every three to four years. This time period could be extended if the stage is not highly utilised.

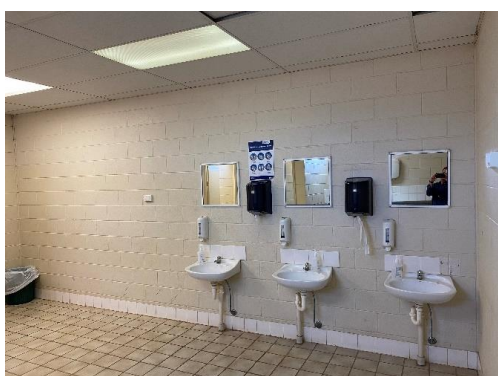
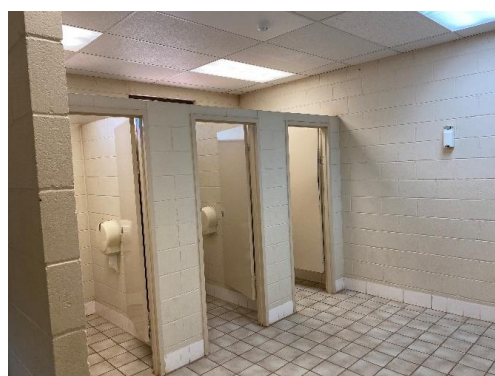
The amenities are dated however in fair condition. To upgrade the amenities would be a major exercise. It would be recommended that the internal partition block walls be removed, toilets, basins, urinals etc be removed, floor tiles lifted and removed. The existing T-Bar ceiling is not considered suitable within amenities, this would also be recommended to be removed and new flush plasterboard ceiling provided. New light weight partitions for the toilets, new toilets, vanity bench with semi recessed basins, individual urinals are recommended to update the amenities.

Figure 14 - Dated Amenities

Figure 15 - Dated Amenities

A major refurbishment item, the removal of the existing tile flooring to the amenities, is a key element to provide a face lift to these areas and to modernise them. The issue here is that this is a costly component of the works however will add to the revitalisation of the amenities overall. The addition of covering the existing block walls with plasterboard could also be seen as an opportunity to modernise the environment. Alternatively, the existing block walls dividing the toilets could be removed and replaced with light weight partitions which could allow additional toilets to be provided as part of the redesign to the amenities area.

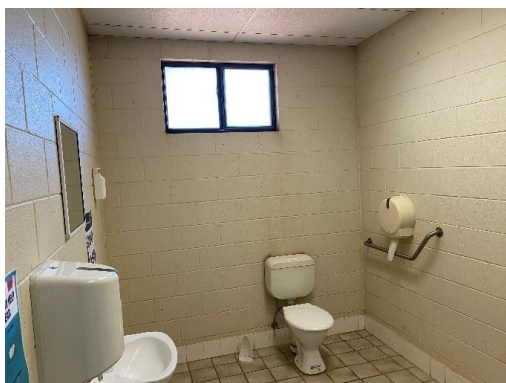
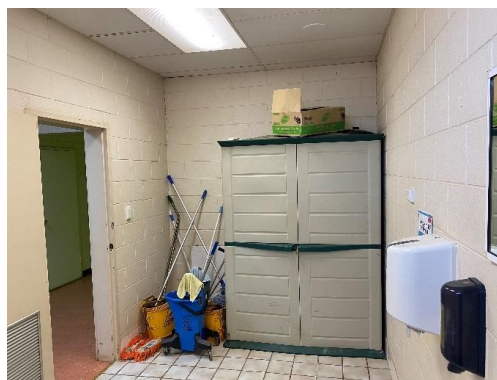
Currently the Disabled Toilet (PWC) is mixed use and is non-compliant. As part of the Amenities upgrade the disabled toilet will need to be updated to reflect current Australian Standards. The room dimensions are far greater than required for a disabled toilet however the fixtures and fittings including grab rails are non-compliant and recommended to be upgraded.

Figure 16 - PWC Toilet

Figure 17 - PWC Toilet used for Storage

Although the PWC measures above the minimum dimensions the location of the storage equipment impacts the clear area required to access the PWC and doorway. As part of the redesign of the PWC it would be recommended that a cleaner's cupboard be built in to avoid the current issues.

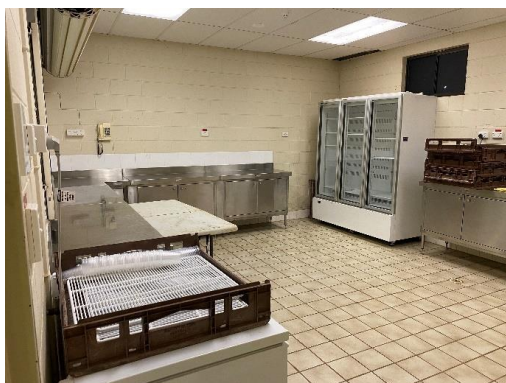
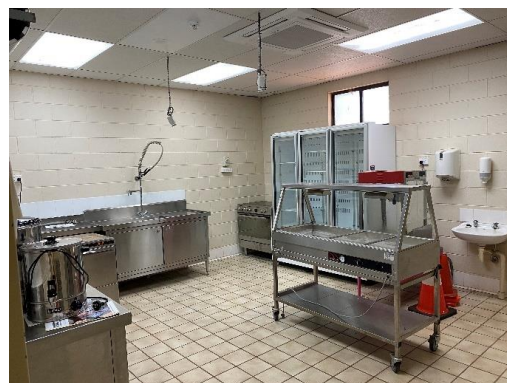
In much the same light as the amenities, the kitchen and bar would benefit from a refurbishment. The floor, walls and ceilings are dated and showing signs of general wear and tear. The T-Bar ceiling is not ideal for a food preparation area. The existing equipment in the kitchen would lead to a view that this is a food preparation area and not just a serving area. It would be recommended that a flush plasterboard ceiling be provided to both areas.

Figure 18 - Bar

Figure 19 - Kitchen

Much like the amenities a major refurbishment item, the removal of the existing tile flooring to the bar and kitchen, is a key element to provide a face lift and to modernise them. This is a costly component of the works however will add to the revitalisation of the area overall. In addition to aiding in the cleaning requirements for food preparation areas where easy to clean surfaces are necessary, tiling the walls to the bar and kitchen would provide a modern look and feel.

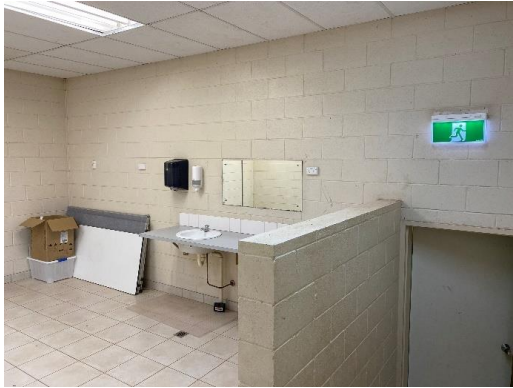
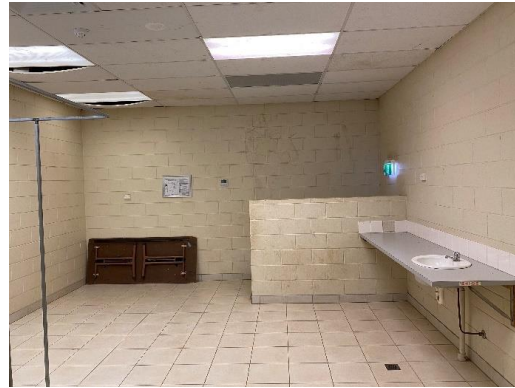
Side of Stage Change Rooms are generally showing signs of wear and tear however the floor tiles are in very good condition and appear to have been a recent addition.

The walls are painted block walls, again showing signs of age.

Figure 20 - Side of Stage Change Rooms

Figure 21 - Side of Stage Change Rooms

The T-Bar ceilings in both Change Rooms are in average condition with signs of water damage, dropping ceiling panels and poorly secured T-Bar frame.

The Change Rooms would ideally need to be repainted and the ceiling addressed. It is recommended to investigate the T-Bar frame further to determine if additional vertical supports are required and to ensure the bar spacing is fixed in place. New acoustics ceiling tiles should be provided throughout the Change Rooms.

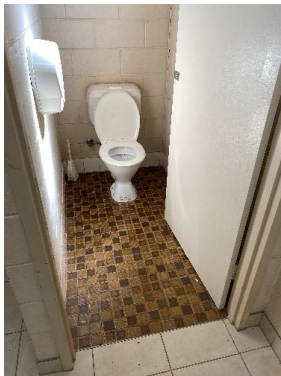
Figure 22 - Change Room Toilet

One Change Room has a toilet which is in average condition. The toilet is recommended to be replaced at the same time as the Amenities are upgraded. The floor tiling could also be replaced at the same time although not critical.

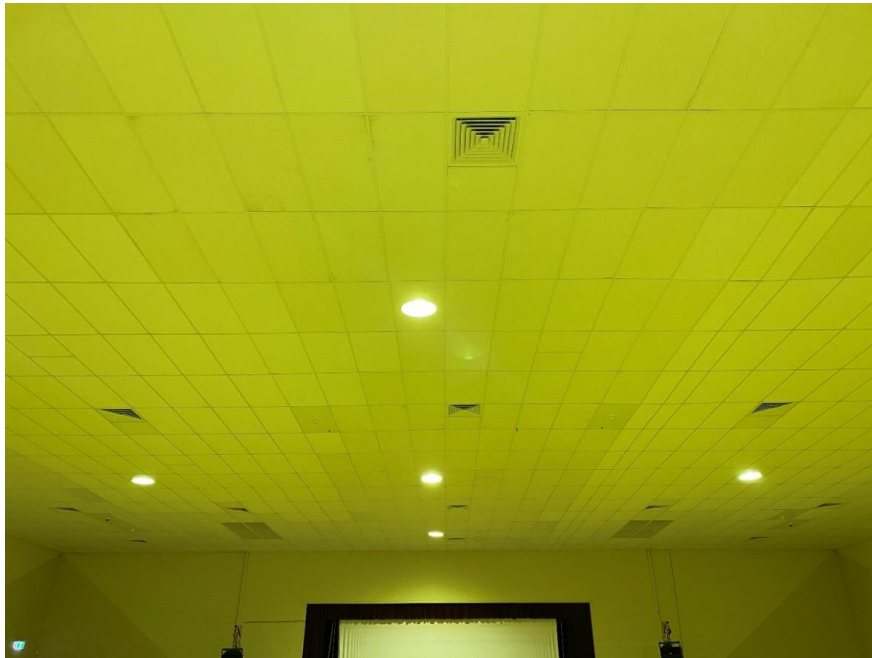
The main auditorium ceiling is a T-Bar ceiling 5500mm AFFL. The ceiling tiles are of various condition noting that it appears that tiles are replaced as and when required. The current design of the auditorium including the ceiling is a very simplistic design which presents as a cube in essence. An option to consider for the ceiling layout is to provide various finish levels by the use of bulkheads and also include suspended elements which aid in acoustic treatments.

Figure 23 - Auditorium Ceiling

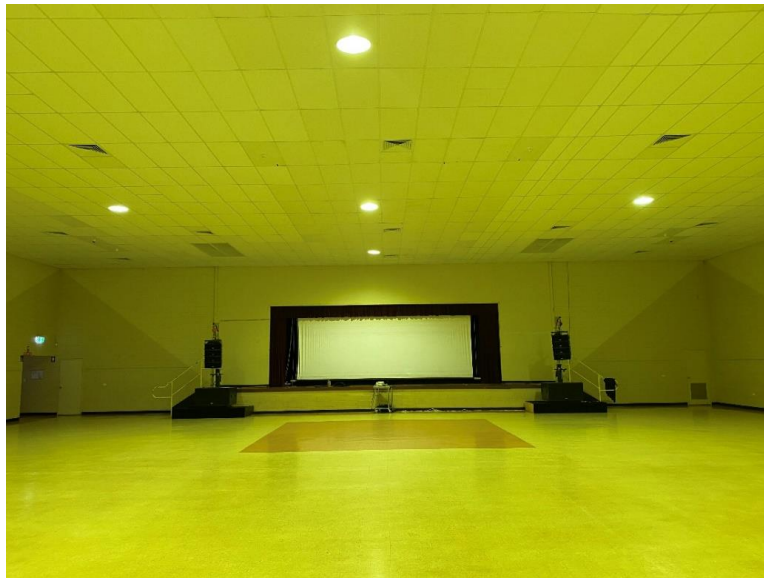
The stage opening could be increased as the wall to either side of the stage is light weight however the result would be the loss of the side stage waiting areas which can be crucial for live stage performances. Some additional structural supporting members may be required for the mounting of curtains, stage screen, light rigging etc. It would be best to discuss the stage opening with local performance members to determine the suitability of the current arrangement and amount of area required for staging and waiting areas to either side of the stage. Increasing the stage frontage may be more of a hindrance than been beneficial to the facility.

Figure 26 - Stage
